Ipstones Conservation Area Appraisal

The Ipstones Conservation Area Appraisal was adopted by Staffordshire Moorlands District Council on 11th September 2007, following public consultation.

Ipstones Conservation Area was established in 1977 and its boundary amended in 1993.

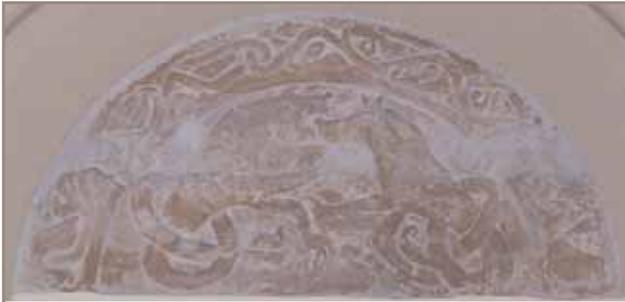
2.1 The stone timpanum

2.1 The name Ipstones is Anglo-Saxon, and means Ippa's stone. There is a carved stone timpanum in the church of 11th century date (2.1) but there is no mention of the settlement in the Domesday Book.

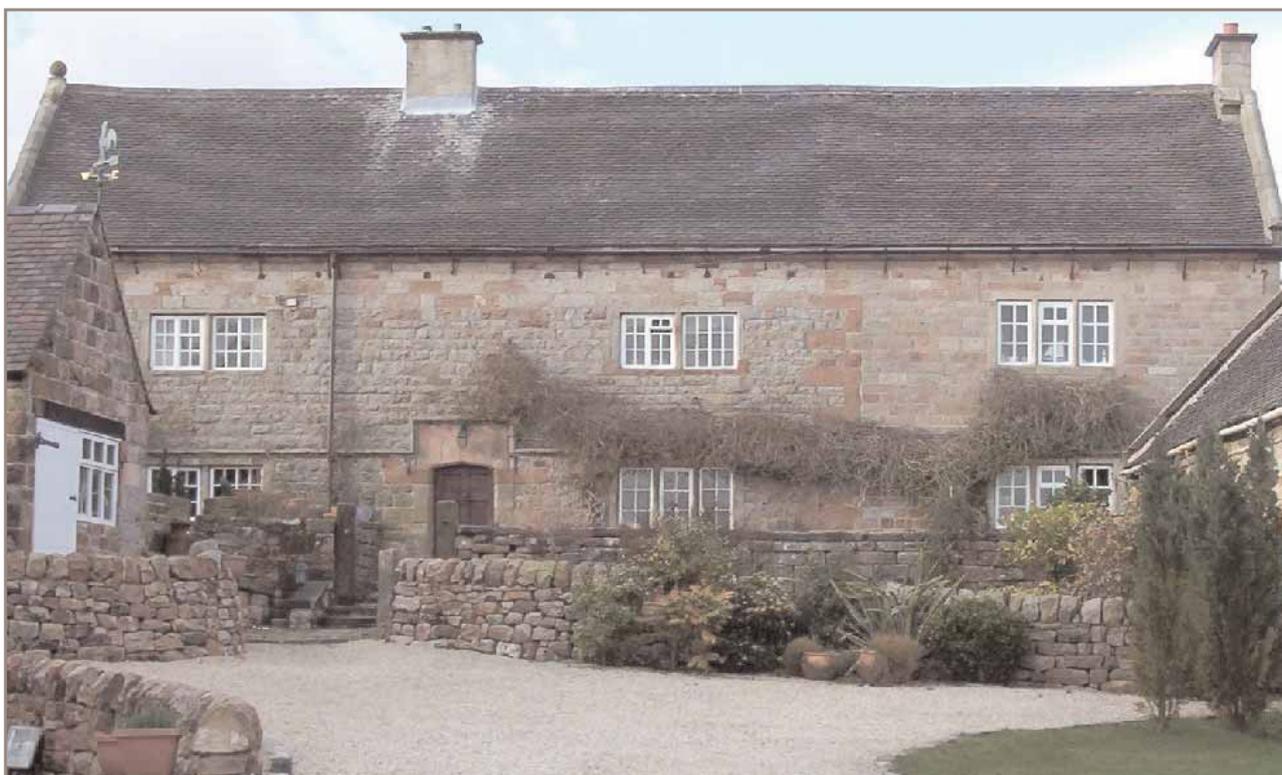
5.1 Meadow Place. The front door opens into a lobby, the 17th century alternative to a porch. In the 18th century, the roof was raised, an extra bay was added to the right of the early house and the coping moved to the new gable end.

8.18 The characteristic roof pitch was around 40° and a mixture of straw and rushes was used. When thatching was abandoned, the side walls might be raised by three or four courses to give greater headroom in the attics, leaving the gable walls unaltered. Meadow Place was altered in this way in the 18th century (5.1).

This is the arrangement to be found at 62 Brookfields Road (5.2) and in a more up-market version at Meadow Place which has its lobby entrance in the centre of the original building (5.1).

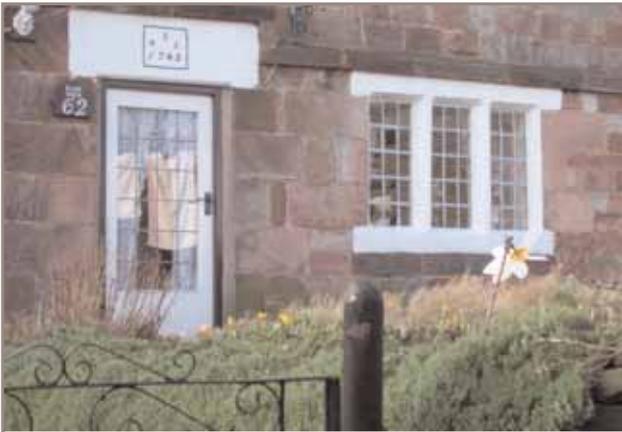
5.2 East View, 62 Brookfield Road

8.32 It is rare for 17th century glass to survive, and rarer still for it to be in its original leadwork. Most mullioned windows contain replacements, either single sheet of glass set straight into the stonework, set in a metal surround, or set in a wooden surround, with or without a casement. Rectangular leaded panes containing some of the original glass survive in an 18th century house at 62 Brookfields Road (5.2).

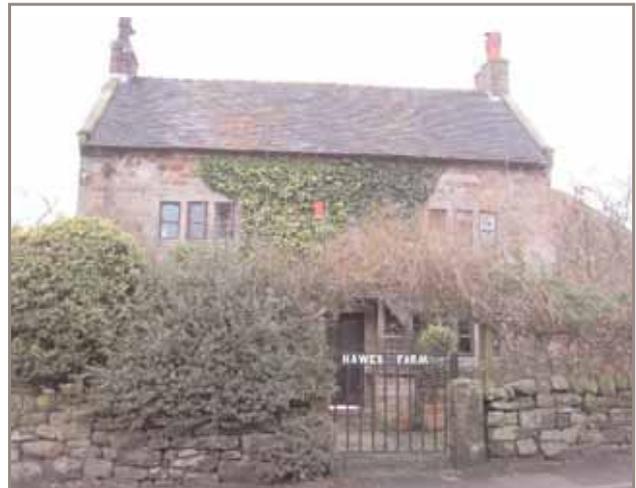
5.4 Hawes Farm, 53 High Street

5.4 The late 18th and early 19th century houses vary in building materials, style and function. Some, like Hawes Farm (5.4) and 5-9 High Street (5.5) are conservative in their style, and have block-mullions⁴ to 3- or 4-light windows, the successors of the chamfered windows at Meadow Place. 5-9 High Street, has an asymmetric façade a common feature in the earlier houses, where interior function was more important than external fashion; Hawes Farm has the deep, gable lit attic space associated with cheese storage.

8.29 By 1750 a simpler version had appeared, with straight-cut masonry on the exterior and including 'block' mullions with a flat outer face (8.16). There are a number of examples in Ipstones, including Hawes Farm and 5-9 High Street (5.4 and 5.5).

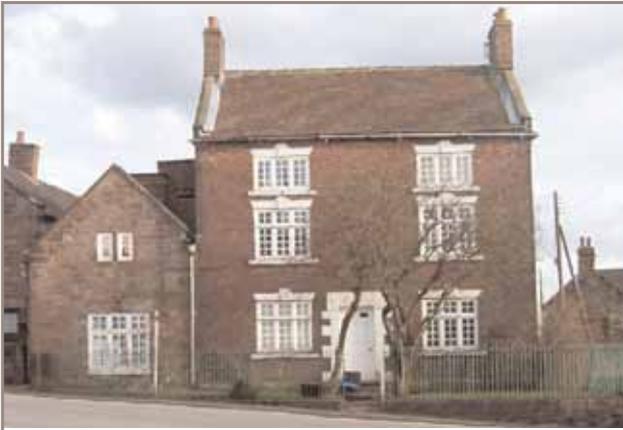
5.6 *No. 4 High Street and Twist Intake*

5.6 The larger, three storey buildings include Twist Intake (No. 2 High Street), and the Grove (No. 5 Church Lane). Twist Intake (5.6) is built of brick, and has small-paned side-hung casement windows in mullion and transom⁵ frames. The Grove is built of stone, and has taller windows containing sashes. A pillastered surround and a pediment lend weight to the central doorway, as does the Serlian window above (5.7).

5.8 No. 4 High Street (5.6) is in a category of its own because of its small scale, and cheek-by-jowl relationship to Twist Intake. Its original purpose is uncertain, but the 1851 census indicates the village had numerous small shops and workshops.

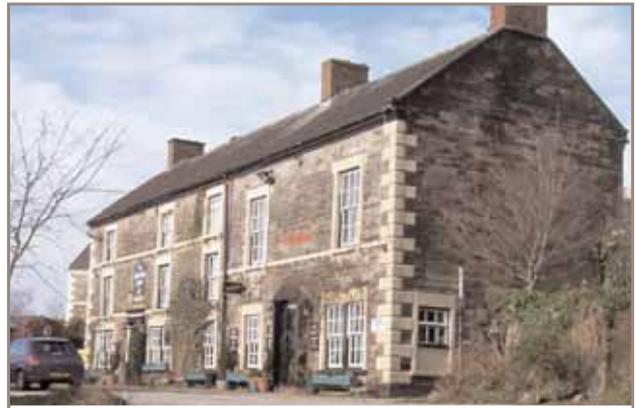
5.8 *The Red Lion*

5.7 Also among the larger buildings are the Red Lion (5.8) and the Marquis of Granby (5.9). The Red Lion is of stone, and is unusual in coupling a pair of irregular blocks, one of two, and one of three storeys, both with plain bands between storeys, raised painted window surrounds, rusticated quoins, and paired frames to some of the ground floor windows. By contrast, the Marquis of Granby started life as a plain symmetrical brick building, with simple gauged heads to the windows. Both may once have been private houses but were inns by 1851.

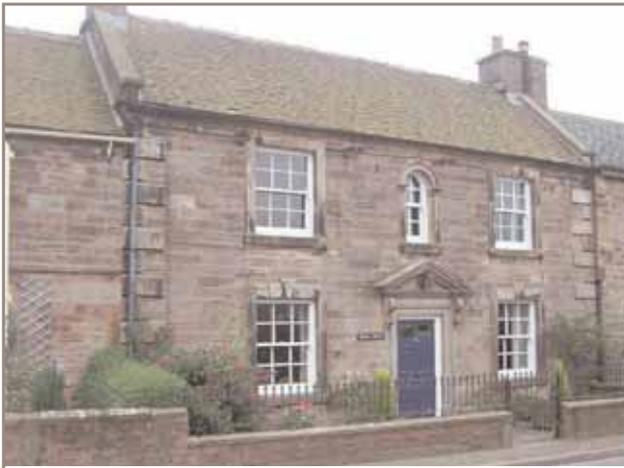
5.10 Brook House

5.8 The smaller, two-storey houses include the mid-18th century Brook House (5.10), built of well-dressed mellow pink stone, with a fine pediment, arched upper window, raised window surrounds and quoins. The Sea Lion Inn (5.11) is in a similar style but with raised quoins to its central doorway, and large pane 19th century sashes. Nos. 26-28 High Street (5.12) are dominated by the later house, where bay windows and a porch mask the original design. No. 14 High Street (5.13) is a mid-19th century re-fronting of an 18th century house, and retains round-arched heads with raised keystones to both the doorway and the central upper window, and the pleasing pattern of its original sash windows and fanlight.

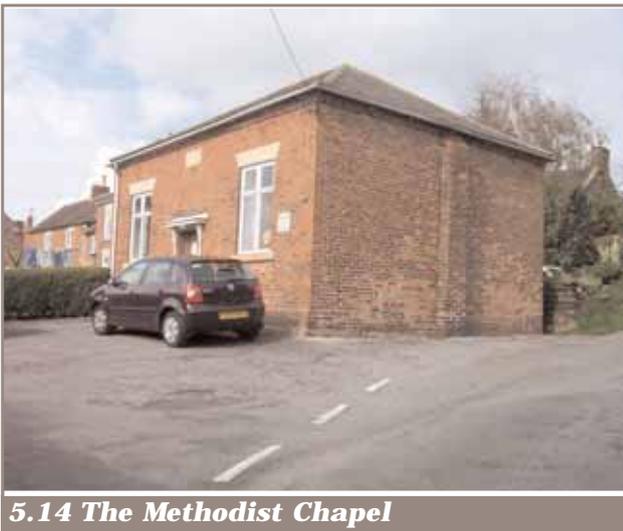
5.14 The Methodist Chapel

- 5.9 By the mid-19th century the village was well served by places of worship. The church was rebuilt in 1789-92 at the expense of the Sneyd family, and a series of chapels was to follow.
- 5.10 The Methodist Chapel, shown on current maps as 'Sunday School' is a small building with a hipped roof, and dated 1838 (5.14). Its (unlisted) successor, built in 1861, forms a prominent part of the view from School Green (5.3). A third chapel, built for the Primitive Methodists in 1837, is also unlisted. Much altered, only its pointed windows and plaque remind us of its origins (5.15).

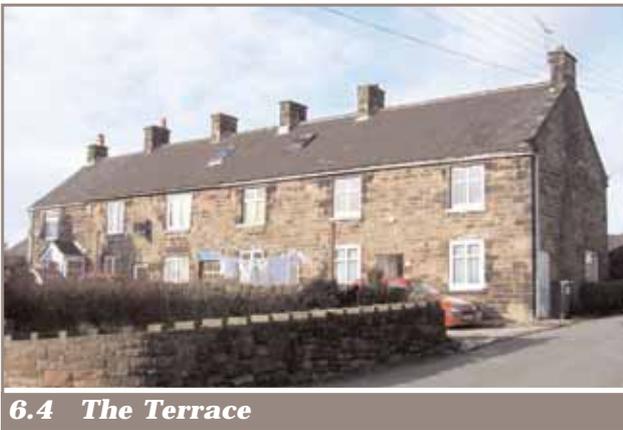
6.4 *The Terrace*

- 6.1 The workers' housing and their workshops and sheds are under-represented in the listings, but are key features in terms of historic importance, as were the village shops. A prominent example survives on the main crossroads, still occupied by a butcher's shop (5.5), but small single storey buildings, many with double doors, or workshop openings are still much in evidence (6.1 and 6.2).
- 6.2 Purpose built workers' housing is represented by Mount Pleasant, a mellow stone-built terrace presenting a series of roof heights as it drops across the contours to the south of the School (6.3). By contrast, the grey stonework of The Terrace is set along the contours and forms a single unbroken block (6.4).

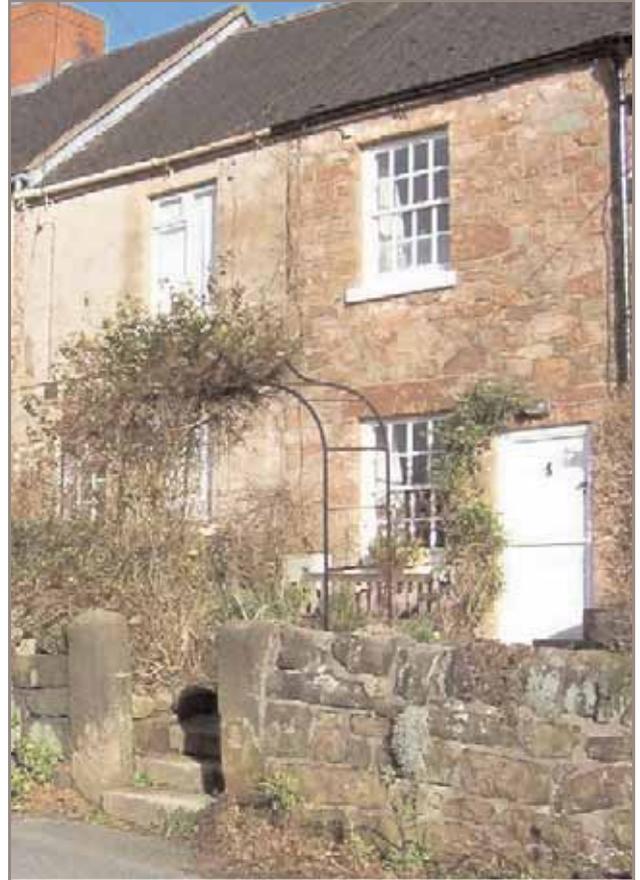
6.5 *No. 25 Mount Pleasant*

6.3 Two examples stand out. No. 25 Mount Pleasant retains well-maintained sash windows and a boarded stable-type door, also its original stone gateposts and walling (6.5). No. 4, High Street, once a pair of cottages, shows how well these properties look when they retain traditional doors and windows, and unaltered facades (6.6).

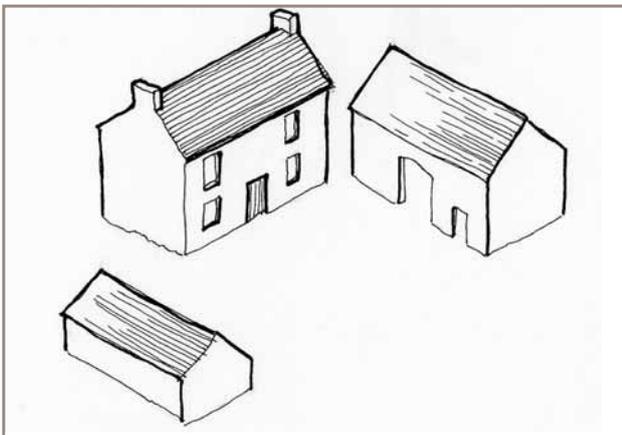
- 8.1 Traditional farmsteads in North Staffordshire consist of a detached house, and one or more detached outbuildings serving a variety of functions (8.1). There is no set pattern to their arrangement, which is designed to fit the lie of the land. On steep slopes large buildings will lie along the contours, on gentler ground they may be arranged round a courtyard, as at Meadow Place.
- 8.2 Farmsteads with farmhouse and barn under one roof were cheaper to construct, and are found mainly in areas of late enclosure where smallholders were struggling to make ends meet (8.2). They are rare in village centres or on the older farms where, as in Ipstones the elements are normally detached.

8.1 *Farmhouse with detached farm buildings*

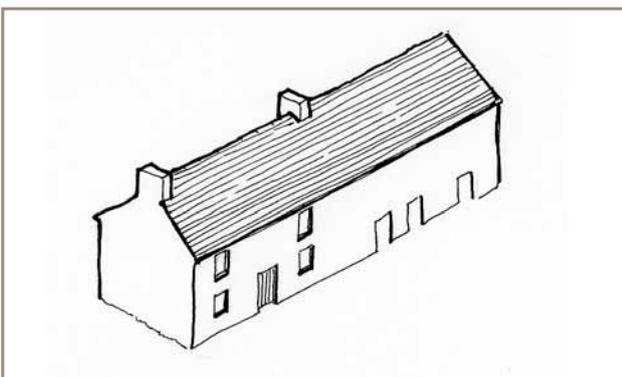
8.2 *Farmhouse and farm buildings under one ridge line*

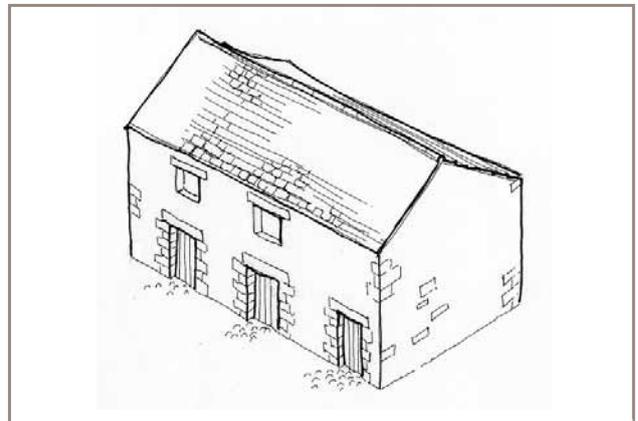
- 8.3 Large outbuildings may be called barns, irrespective of function. They may be cattle sheds with three or five smaller entrances and have haylofts with pitching holes (8.3), or threshing barns with a cart arch and threshing floor flanked by full-height storage space for grain crops and have narrow ventilation slits, or a combination of the two (8.4). Some have a granary on an upper floor accessed by an external staircase.

8.3 *A three-door cattle shed with hayloft over*

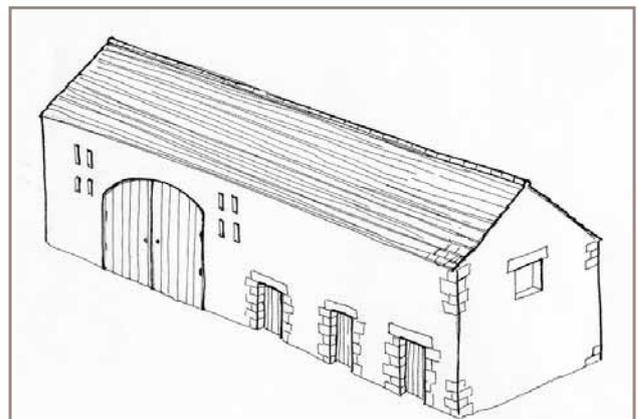
8.4 *A threshing barn and cowhouse combined*

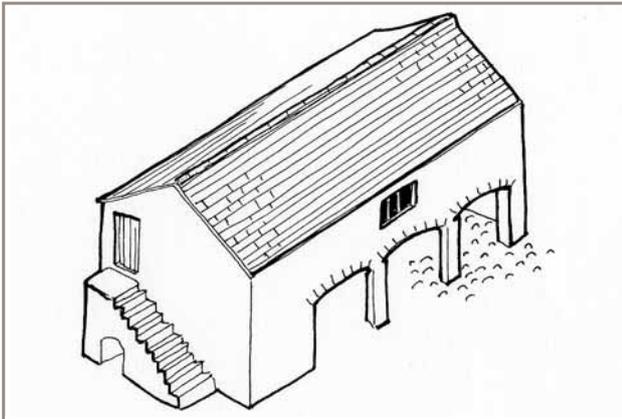
8.4 Smaller outbuildings may include a granary over a cart shed (8.5), a stable, a shelter shed, or a pig-sty with a hen house above (8.6). The stable will generally be near the house, have a larger door than the cowhouse, and have a window adjacent to the door (8.7).

8.5 A shelter shed with granary over

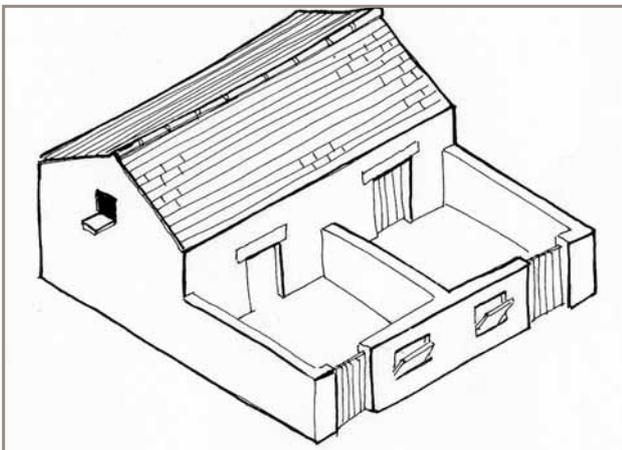
8.6 Pigsties with hen house over

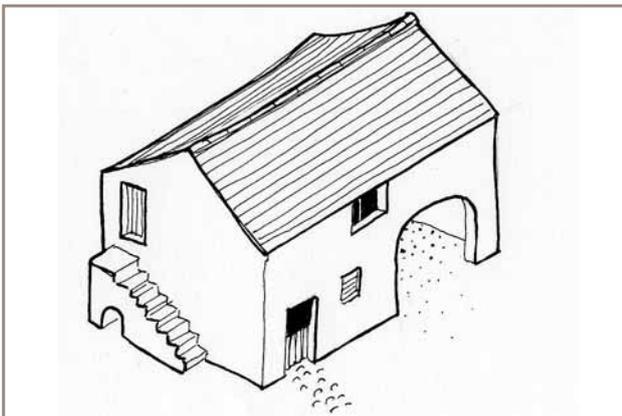
8.7 Hackney stable with granary over

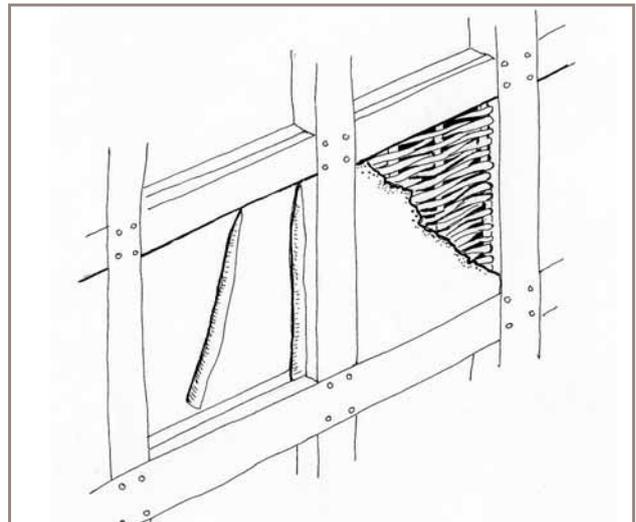
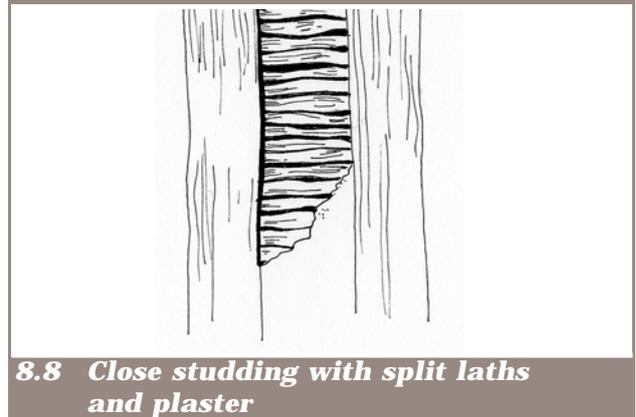
- 8.5 Oak, was the main building material throughout the Middle Ages, except for high status buildings like Ipstones church. Where good building stone was absent timber remained in use until the 17th century.
- 8.6 Walling consisted of either square framed panels with wattle and daub, or close-studding with split laths and daub. Interior walling was still built in this way well into the 18th century (8.8).

8.8 Square framing with wattle and daub

8.8 Close studding with split laths and plaster

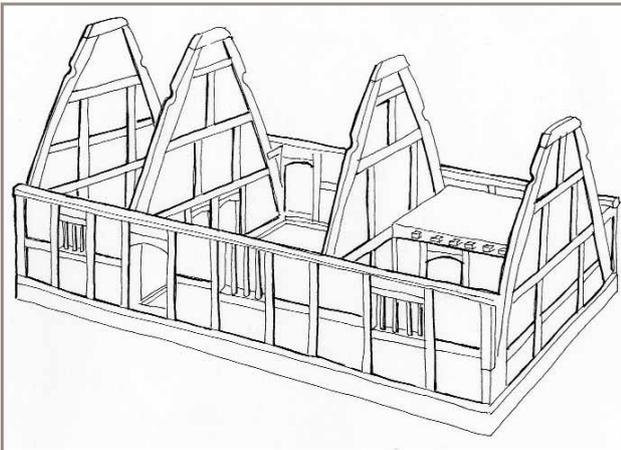
- 8.7 Small buildings might be cruck framed with little or no headroom in the upper storey (8.9). One fragmentary cruck survives in Ipstones parish, in a barn at Foxt.
- 8.8 Larger houses were box-framed and had greater headroom (8.10). At Above Church a timber-framed house was encased in stone in the 17th century, and re-used timbers at Sharpcliffe tell a similar tale.

8.9 Cruck construction

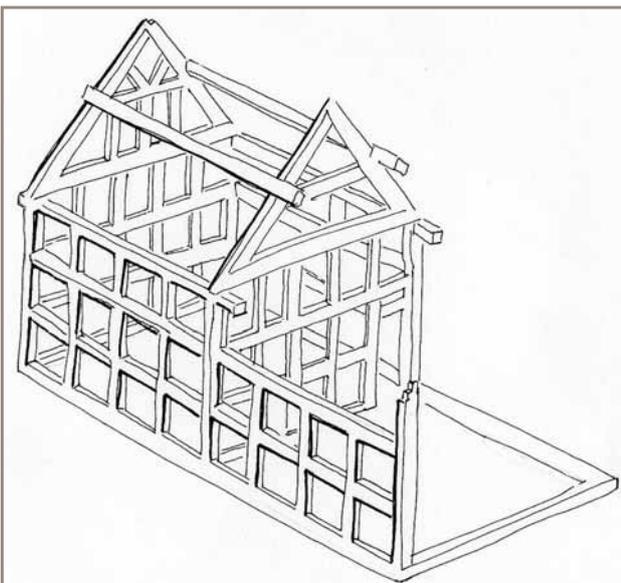
8.10 Box-framing

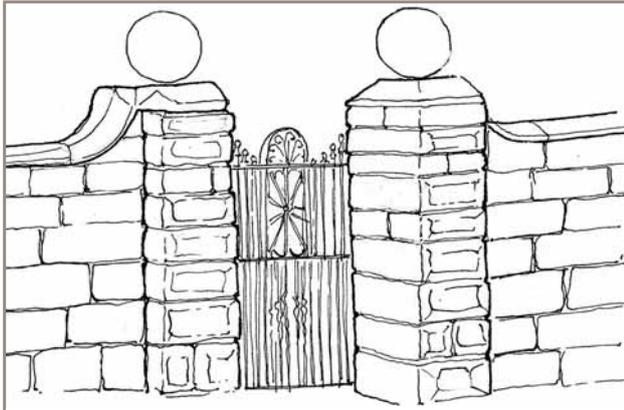
- 8.12 The status of a house and its owner were mirrored in the garden walls. Mortared walling with well-tooled capping stones and decorative gateposts were provided for gentry houses (8.11), and dry stone walls with simple capping stones for farmhouses and cottages (8.12). The latter are particularly important in Ipstones where they once bordered every roadway.

8.11 High status walling and gateposts

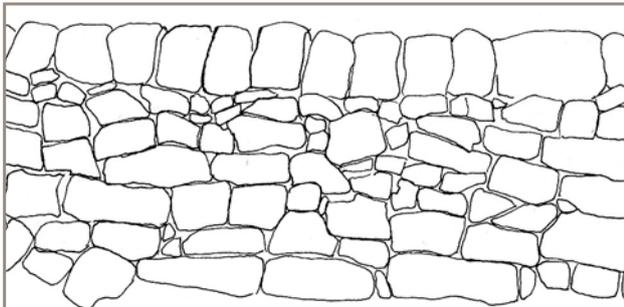
8.12 Drystone walling with the traditional half-round of coping stones

- 7.4 Drystone walls with semicircular capping stones are of particular importance in the Conservation Area, and form the majority of the ancient boundaries. Recent replacements have done little to enhance the area with the occasional exception where a brick wall with stone capping reads well against a brick house.

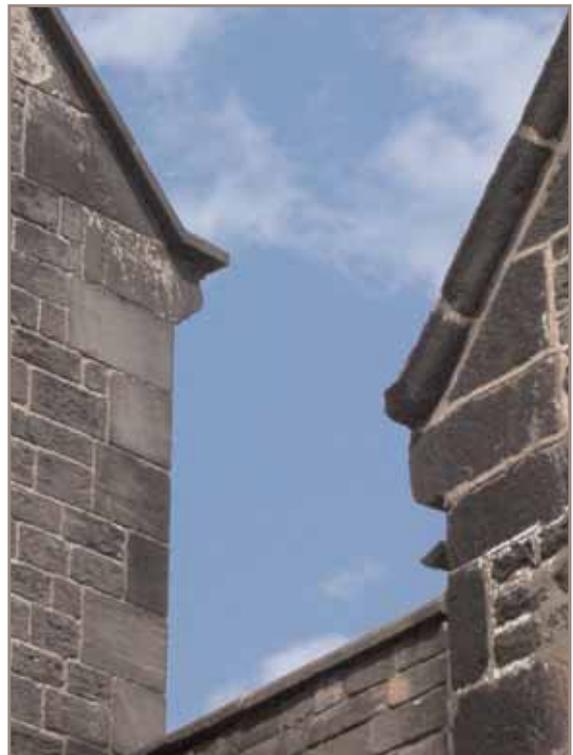
8.13 Coping stones and kneelers

- 8.16 Until the 19th century many roofs in both town and country were of thatch, although surviving examples are rare. The thatch was thick and on stone houses was contained within copings at each end of the gable.
- 8.17 Coping stones were either hog-backed (17th century) or flat (18th and 19th centuries), the latter slightly shaped to throw water onto the roof and towards the guttering system. Hog-backed coping supported distinctive 17th century style kneelers (8.13) which gave way to plainer examples in the 18th century. Coping stones are a feature of the majority of Ipstones Listed Buildings. If a roof of this type was extended the coping would be removed and replaced on the gable end of the extensions as at Meadow Place (5.1).

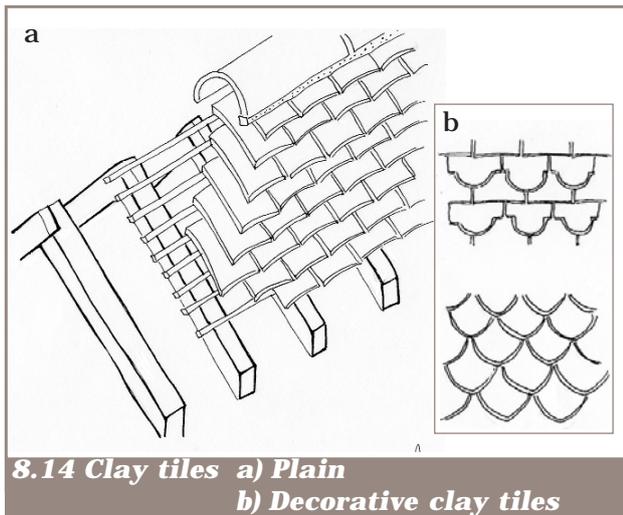
8.19 Stone slates were used on better quality housing. They are now relatively rare, but may survive as a few courses at eaves level with tiles or welsh slate above. Where the long walls have not been raised, and there is no great depth below the coping, stone slates are likely to have been the original roofing material.

8.14 Clay tiles a) Plain b) Decorative clay tiles

8.20 The 19th century saw the expansion of the Potteries coupled to new and better forms of transport. With these came the mass production and distribution of the clay roofing tiles that are now regarded as the typical local roofing material. The majority are plain rectangular tiles, but some fine 19th century roofs use alternate bands of plain and fish-scale or acorn tiles. All were hand made and have an irregularity that cannot be simulated by modern machine made tiles. Only plain tiles are present in the centre of Ipstones.

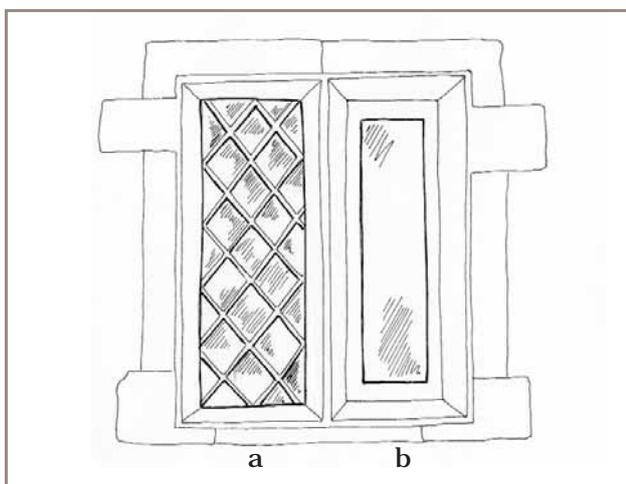
8.27 In the earliest houses glazing was applied straight into the structural surround, without recourse to a wooden window frame. As a result, modern window-frames sit uneasily in 17th or early 18th century window openings, blocking the light and appearing clumsy, an effect compounded by the addition of double-glazing (8.15).

8.15 Mullioned windows: traditional and non-traditional methods of glazing
a) leading with diamond panes
b) wooden frame with single pane

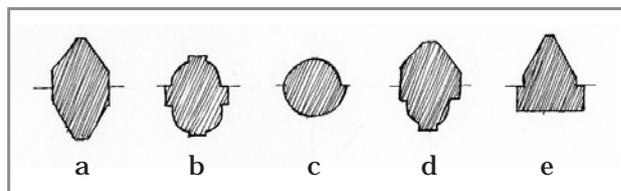
8.16 Mullions: changing styles
a) chamfered
b) ovolo
c) rounded
d) chamfered and ovolo
e) block mullion

⁴ Block mullions have flat outer face, and chamfered inner faces (8.16).

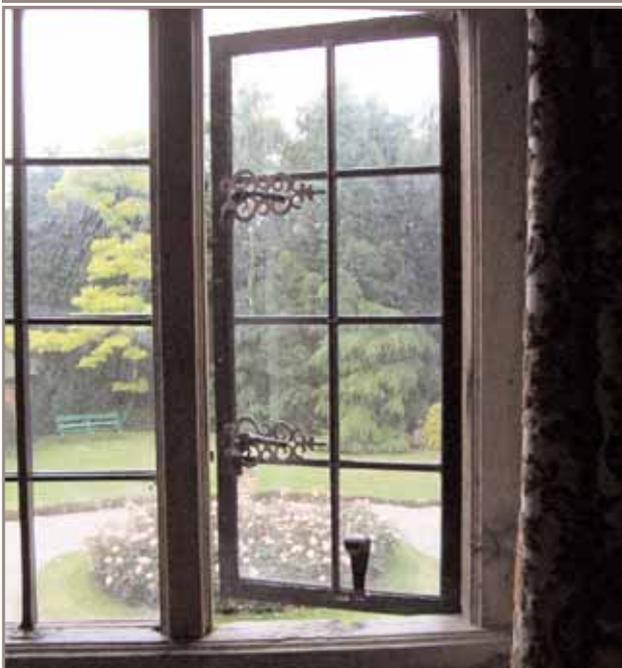
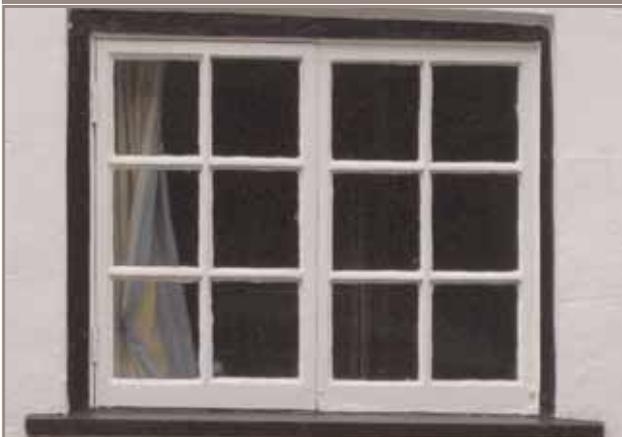
8.17 Casement windows

a) 18th century metal casement

b) 19th century wooden casement

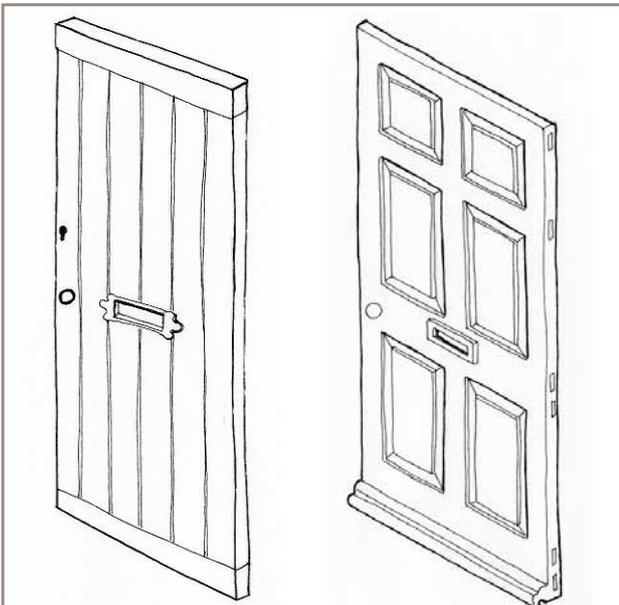
8.40 The simpler buildings in both town and country generally had vertically boarded doors, as did farm buildings. The latter might include stable doors with an upper section could be fixed open while the lower section remained closed. Panelled doors are common as exterior doors for higher status houses, and are often used for the front door of a farmhouse in contrast to plank doors at the rear.

8.19 Doors

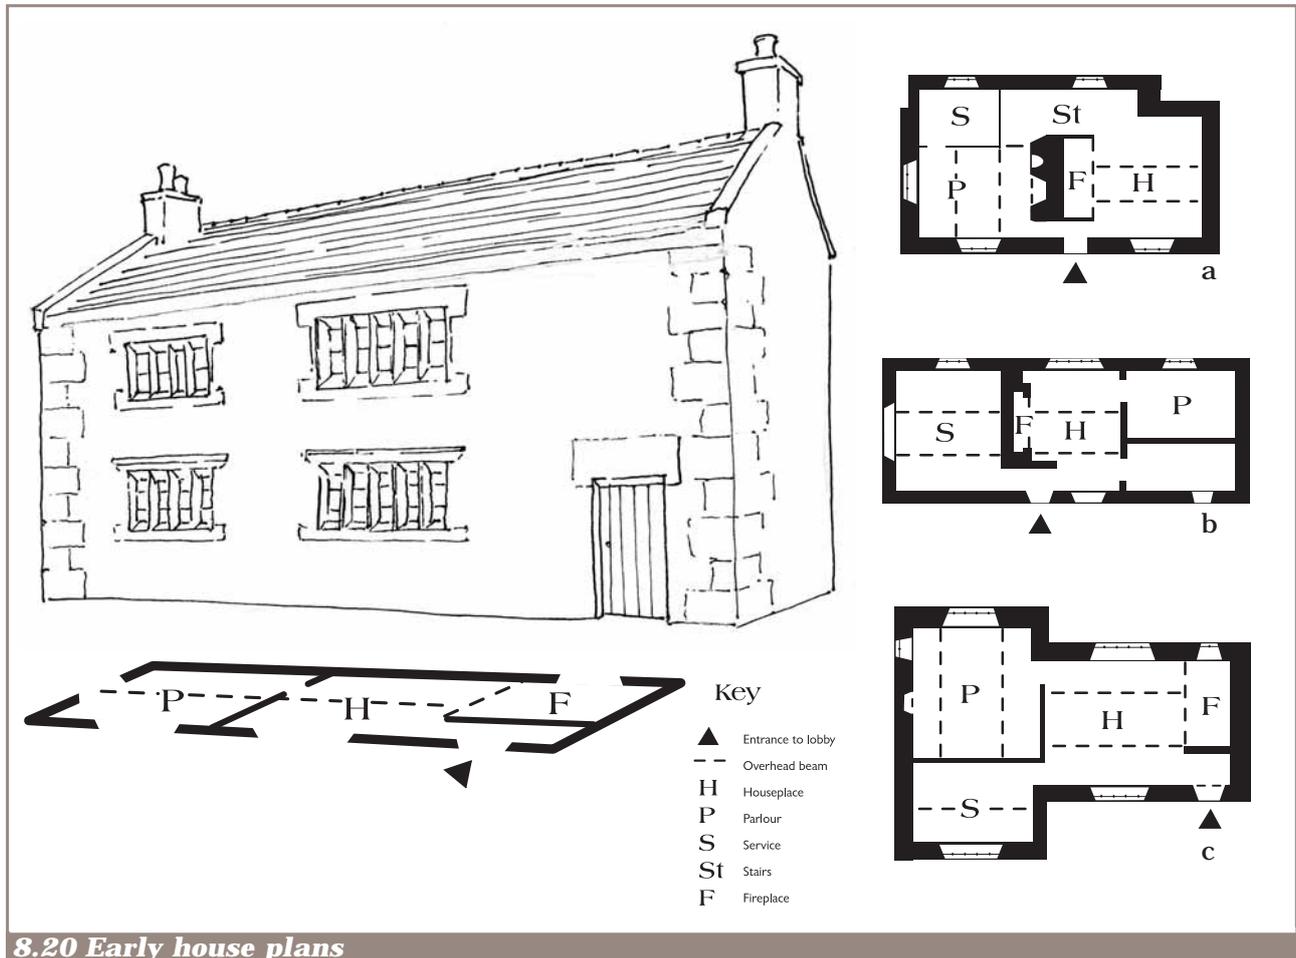
8.20 Early house plans

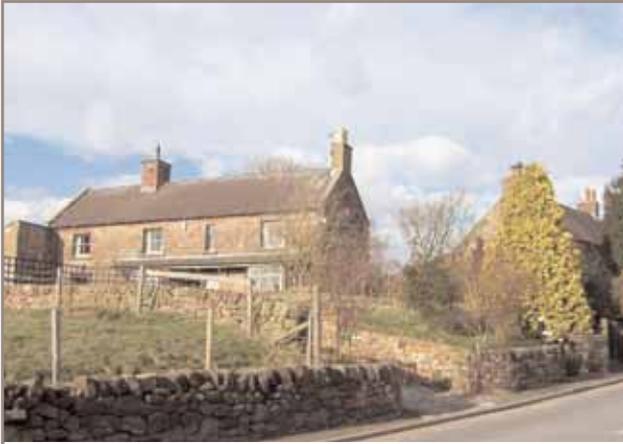
10.6 Best practice is to be found in two recently created parking areas: at both Daisy Bank Farm and Sunnyside (53 Froghall Road) the owners have terraced into rising ground leaving drystone walling at the original height and in a position to conceal the vehicles. At the former, a new entrance was required, and its impact has been minimised by curving the ends back onto the site, so that the oblique view still presents walling and the opening is kept to a minimum **(10.1)**.

10.1 New entrance near Daisy Bank

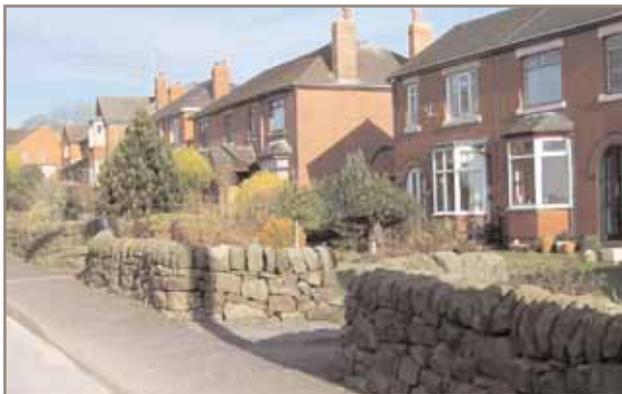
10.7 Best and worst practice is evident on the northern approach to the village. At Nos 36-46, in-curving entrances minimise the effect of driveway entrances (10.2). Elsewhere walling has been hacked away, leaving wide openings with straight ends to the walls, doing maximum damage to the visual effect.

10.2 Entrances at Nos. 36-46 High Street
